August 2, 2017

Project No. 17-7-587

Subject: Geologic Hazards Review for Proposed Additions and Improvements to River Dance RV Park, Parcels 1 and 2, Mosher Parcels, 6700 Highway 6, Eagle County, Colorado

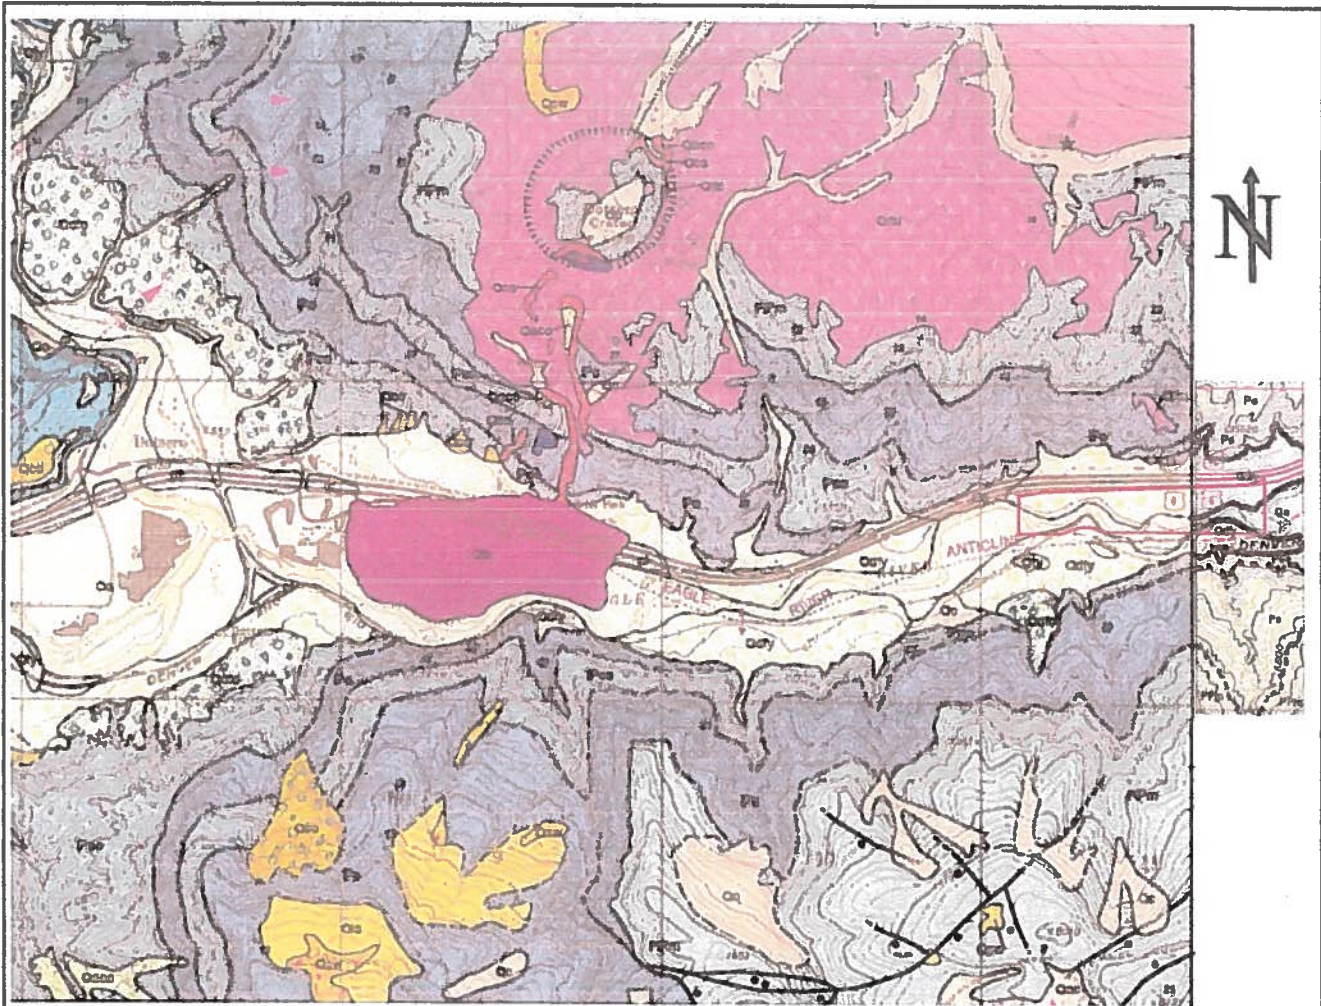
The main geologic features in the project area are shown on Figure 3. This map is based on the published regional map by Streufert and Others (2008).

The modern landscape and surficial soil deposits in the project area are mostly the result of debris flow deposits (Qdfy) from debris flows originating in basins high up on the Eagle River Valley sides traveling in steep incised channels leading down to the Eagle River Valley bottom. These debris flow deposits consist of Holocene-age sediments deposited by sheetwash, mudflows, hyperconcentrated flows, and debris flows. This material is gravelly, sandy, clayey, silt with cobbles and boulders. The cobbles and boulders are mostly angular sandstones derived from the Maroon and Eagle Valley Formations and basalt fragments from the Dotsero Crater. These debris fans can be up to 50 feet thick and are subject to hydrocompression and future debris flows / floods (hyperconcentrated flows). Exploratory borings will be needed to evaluate the thickness and engineering properties of the debris flow deposits at the proposed site.

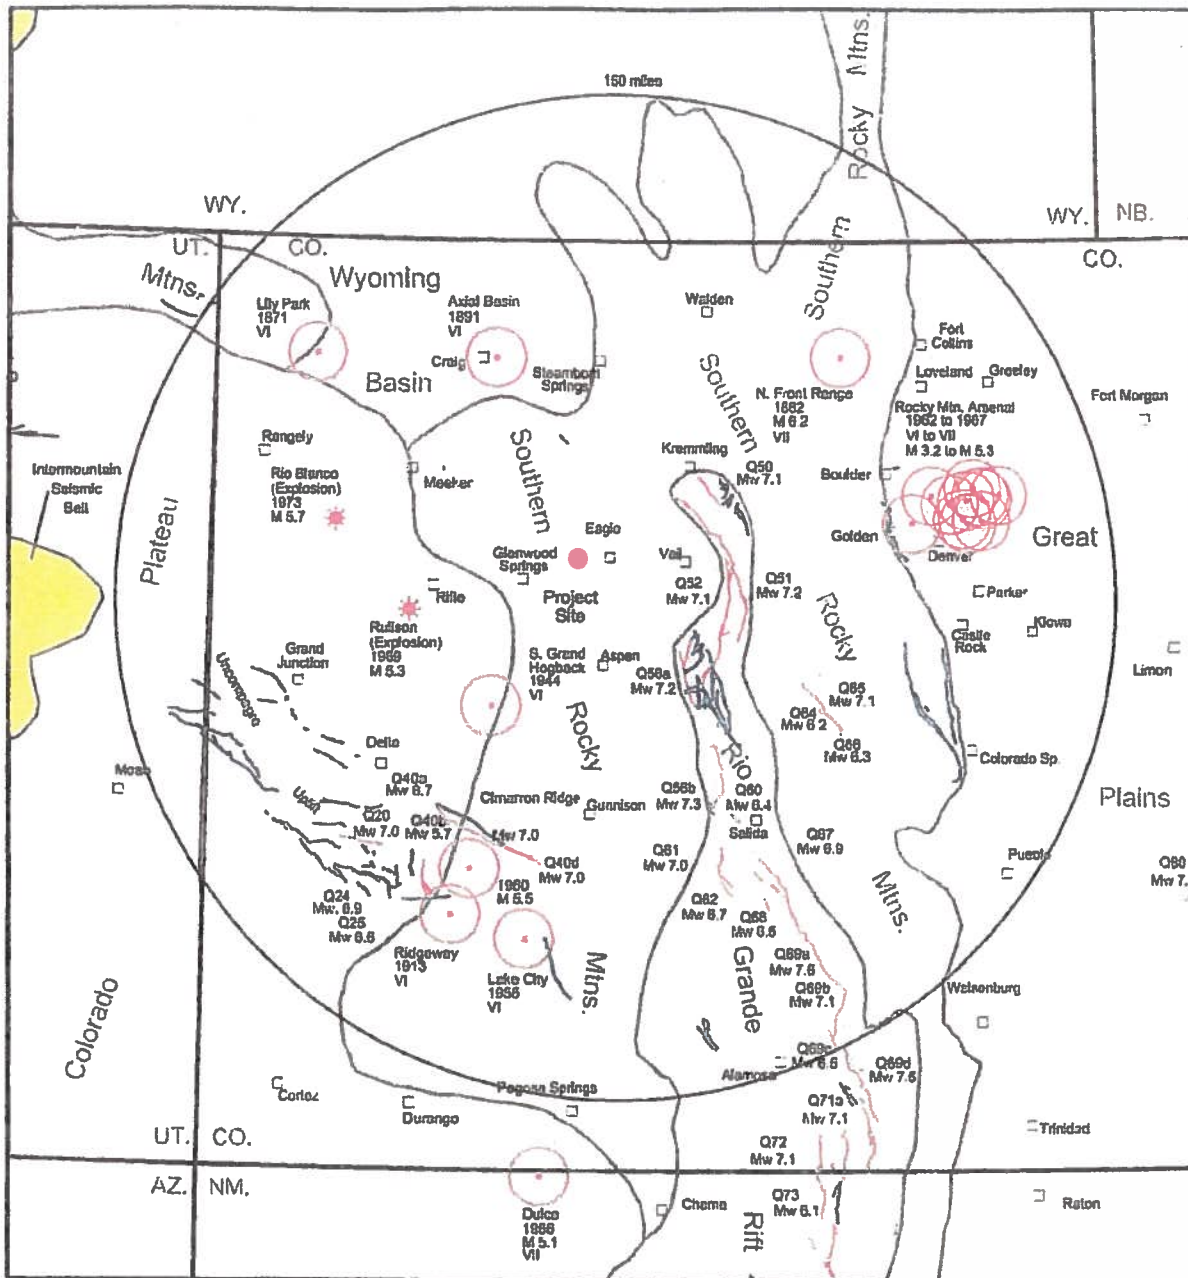
limestone. The closest geologically young faults that are less than 15,000 years old and may be capable of generating large earthquakes are located in the Rio Grande rift to the east of the project area, see Figure 4. The southern section of the Sawatch Fault zone (Fault Q56b) is located about 67 miles to the southeast and the northern section of the Williams Fork Mountains fault (Fault Q50) is located about 46 miles to the northeast. At these distances, large earthquakes on the two faults should not result in unusually strong ground shaking at the project site.

Earthquake Considerations: Historic earthquakes within 150 miles of the project site have typically been moderately strong with magnitudes less than 5.5 and maximum Modified Mercalli Intensities less than VI, see Figure 4. The largest historic earthquake in the project region occurred in 1882. It was located in the northern Front Range and had an estimated magnitude of about $M6.2 \pm 0.3$ and a maximum intensity of VII. Historic ground shaking at the project site associated with the 1882 earthquake and the other larger historic earthquakes in the region does not appear to have exceeded Modified Mercalli Intensity VI (Kirkham and Rogers, 1985). Modified Mercalli Intensity VI ground shaking should be expected during a reasonable exposure time for the residence, but the probability of stronger ground shaking is low. Intensity VI ground shaking is felt by most people and caused general alarm, but results in negligible damage to structures of good design and construction. For *firm rock sites* with shear wave velocities of 2,500 fps in the upper 100 feet, the U. S. Geological Survey 2014 National Seismic Hazard Maps indicates that a peak ground acceleration of 0.07g has a 10% exceedance probability for a 50-year exposure time and a peak ground acceleration of 0.20g has a 2% exceedance probability for a 50-year exposure time at the project site (Peterson and Others, 2014). This corresponds to a statistical recurrence time of about 500 years and 2,500 years, respectively. The soil profiles at

the project site should be evaluated or site-specific shear wave evaluation should be conducted to determine the Seismic Soil Class as described in the 2015 International Building Code.
